TOUGH JOBS

A **GROSCHOPP**® CASE STUDY

+ Insulation Blower

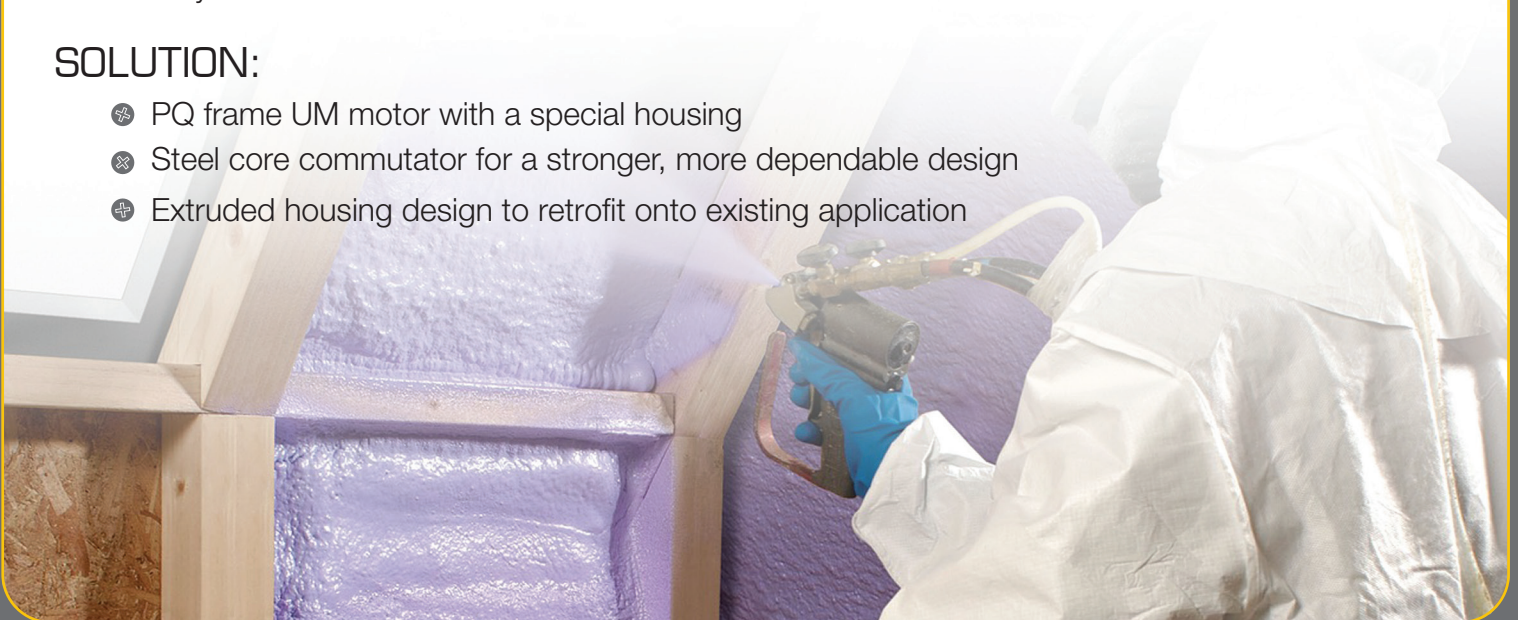
- ⊕ PQ frame UM motor with a special housing
- ⊗ Steel core commutator for a stronger, more dependable design
- ⊕ Extruded housing design to retrofit onto existing application

During the evaluation, Groschopp learned the commutators of the customer's old motors were failing due to quality issues. Groschopp's team engineered a steel core commutator to go into a PQ frame universal motor and designed an extruded housing to allow Groschopp's motors to be a direct replacement for the failing units. The new motors were exactly what the customer needed—strong, dependable, and a perfect fit into their system.
